Manhole Inspection Summary

Manhole # S17I__028MH

Insp Date: **5/14/09 1:07 PM**

Location Address: **2432 BALTIMORE ST**

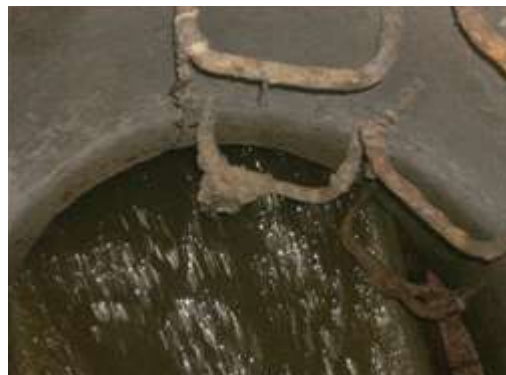
Defect 5

☒ **Evidence Of Surcharge** Depth: **4** (ft.) ☐ Active Surcharge Present

SURCHARGE EVIDENCE ON THE STEPS

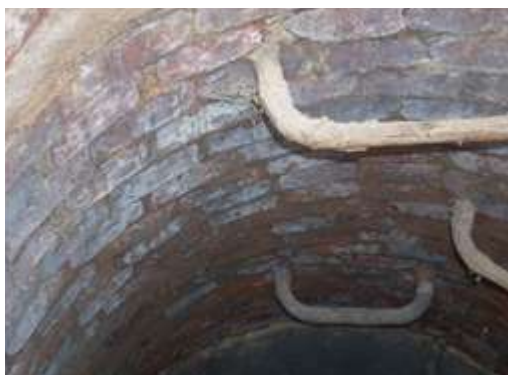
Defect 4

Condition: ☐ Sound ☒ **Cracked** ☐ Root Intrusion ☐ Loose Brick ☐ Deteriorated

Infiltration: ☐ None ☐ Joint ☐ Cracks ☐ Mortar ☐ Roots ☒ **Wall**

INFILTRATION OF CORBEL WALL/CRACKS ON CORBEL

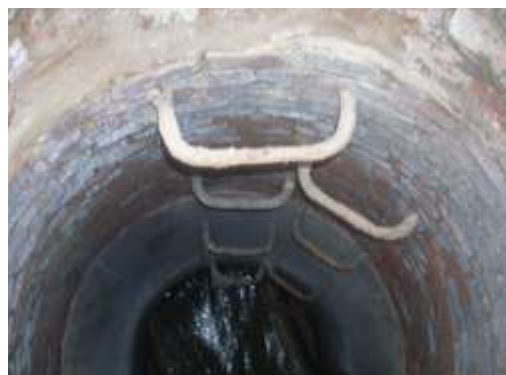
Defect 3

Count: **8** Missing: **0** ☒ **Corroded**

CORRODED STEPS

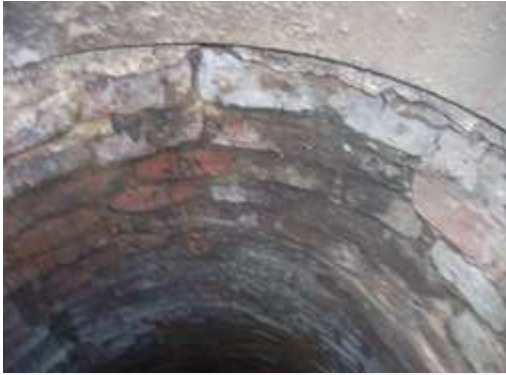
Defect 2

Infiltration: ☐ None ☐ Joint ☐ Cracks ☐ Mortar ☐ Roots ☒ **Wall**

INFILTRATION OF CHIMNEY WALL

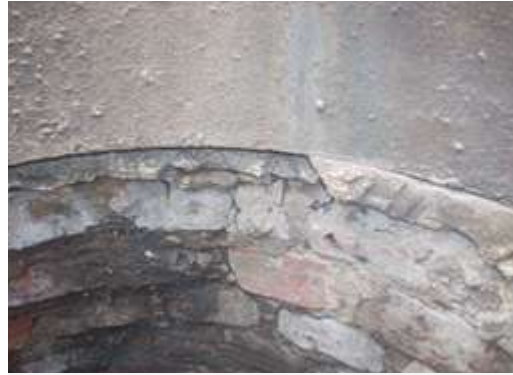
Defect 1

Condition: ☐ Sound ☒ **Cracked** ☐ Root Intrusion ☐ Loose Brick ☒ **Deteriorated**

DETERIORATED CHIMNEY

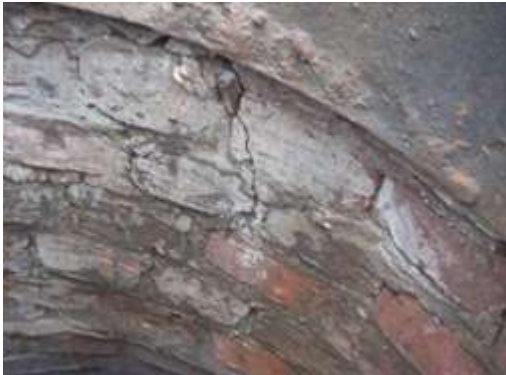
Defect 6

CRACKED CHIMNEY

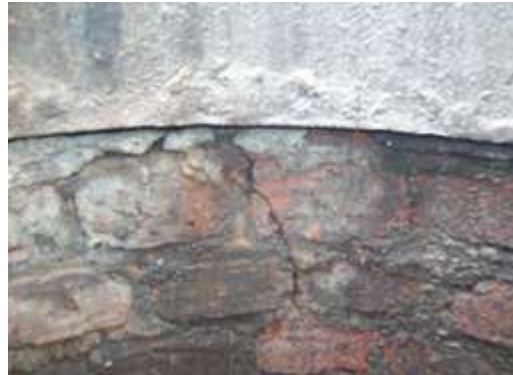
Defect 7

Condition: ☐ Sound ☒ **Cracked** ☐ Root Intrusion ☐ Loose Brick ☐ Deteriorated

CRACKED BARREL

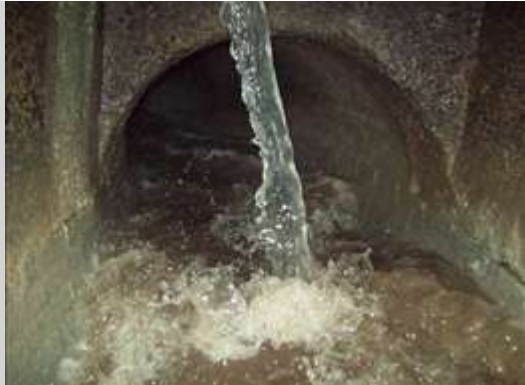
12 O'Clock Outflow

36 in. Circular Gravity Sewer
Pipe Out @ 12 O'Clock

Pipe Height: **33.6** (in.) Direct (Angled)
Pipe Material: **Concrete** ☐ Pipe Lined
Invert Depth: **13.65** (ft.) Flow Characteristics: **Fast**
Deposits: ☒ None ☐ Mud ☐ Sludge ☐ Debris ☐ Grease
Silt Depth: (in.) Deposits Extent:
Infiltration: **None** Pipe Seal Cond: **Sound**

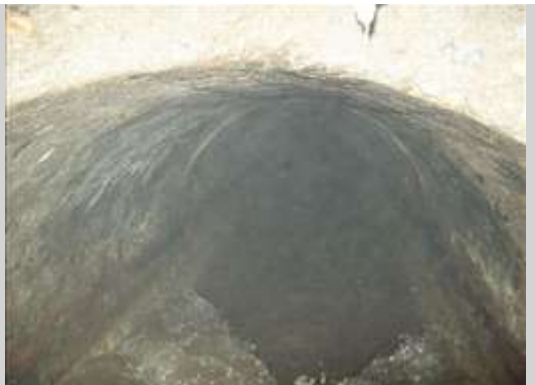
7 O'Clock Inflow

33 in. Circular Gravity Sewer
Pipe In @ 7 O'Clock

Pipe Height: **34.8** (in.) Direct (Angled)
Pipe Material: **Concrete** ☐ Pipe Lined
Invert Depth: **13.53** (ft.) Flow Characteristics: **Fast**
Deposits: ☒ None ☐ Mud ☐ Sludge ☐ Debris ☐ Grease
Silt Depth: (in.) Deposits Extent:
Infiltration: **None** Pipe Seal Cond: **Sound**

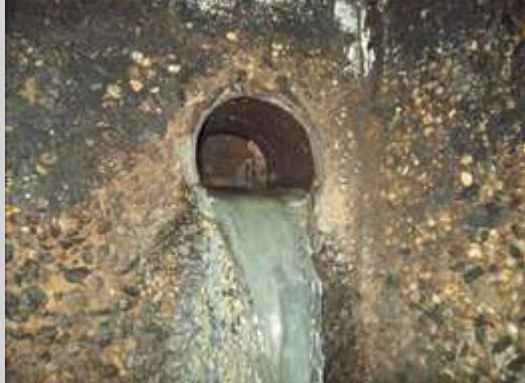
9 O'Clock Inflow

10 in. Circular Gravity Sewer
Pipe In @ 9 O'Clock

Pipe Height: **8.4** (in.) Direct (Angled)

Pipe Material: **Clay** ☐ Pipe Lined

Invert Depth: **8.10** (ft.) Flow Characteristics: **Fast**

Infiltration: **None** Pipe Seal Cond: **Sound**
